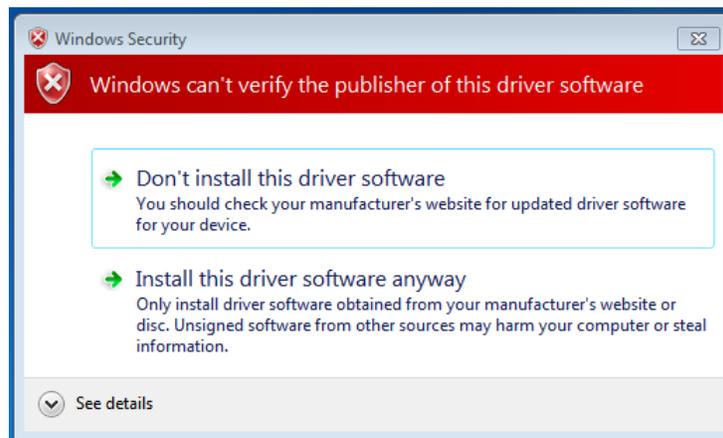
Since MultiCam 6.10 a Windows Security warning (see screenshot below) may be displayed when installing the MultiCam driver package.

This warning occurs when the *VeriSign Universal Root CA* certificate is missing from the Windows certificate store, which can happen if the system is not connected to the Internet and thus does not receive root certificates updates. This issue can be solved by installing this missing certificate, which is available in an archive that can be downloaded [here](#), on the Symantec website.

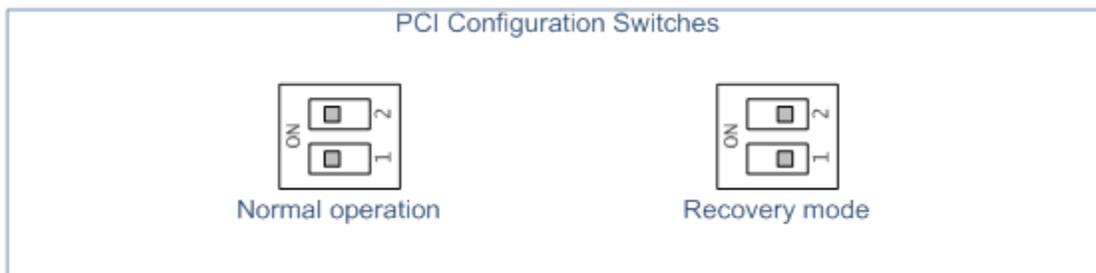
For normal operation of the board, both switches must be in the ON position.

Should recovery mode be enabled by error, the Grablink board appears as "GRABLINK Base/DualBase/Full/Full XR (Recovery)" in Windows Device Manager and is not functional. To restore normal operation, power off the PC, change the switches to normal position and then reboot.

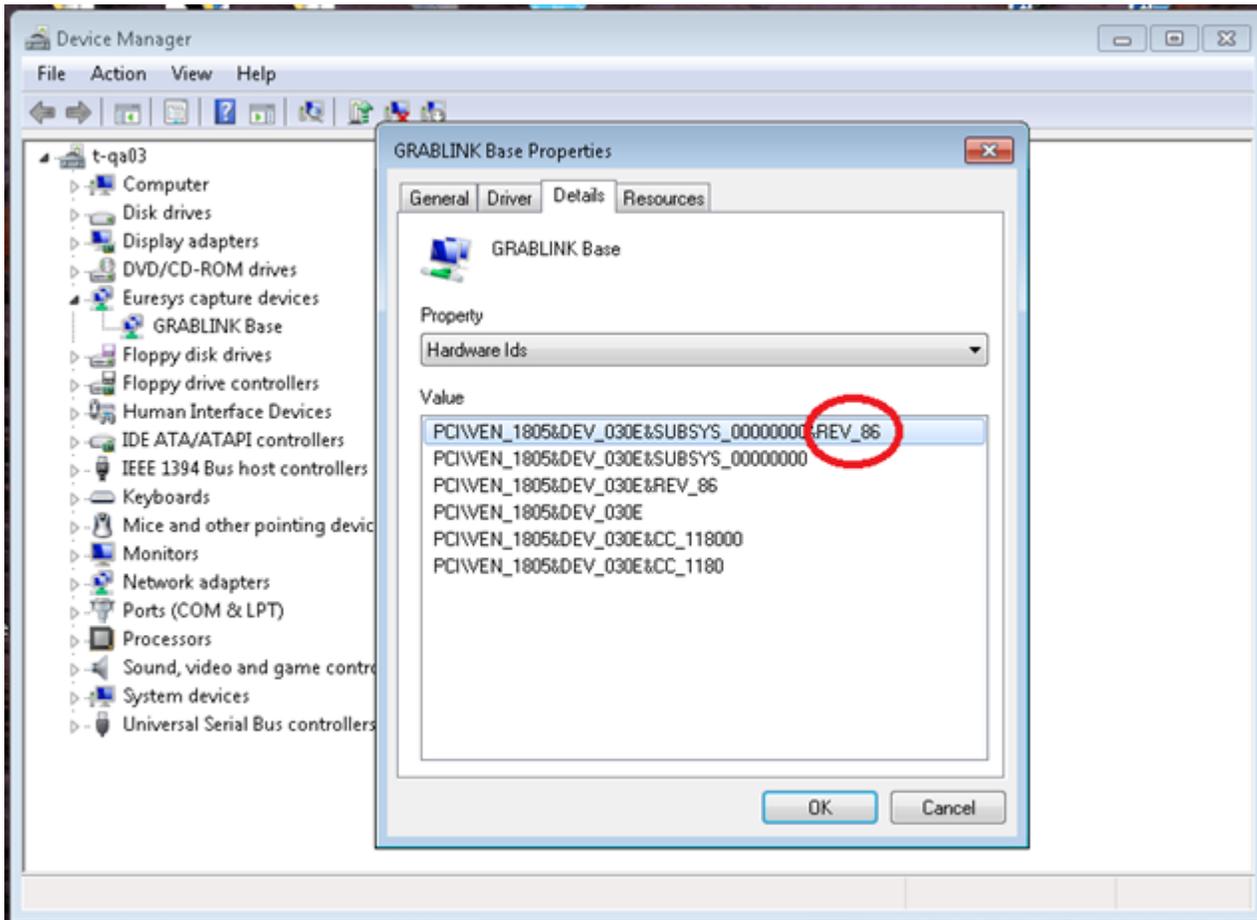
1 - Using Windows Device Manager - Properties Dialog (values are displayed in hexadecimal form)

Some cards may infrequently fail to start properly after power up (PC cold boot) and are not detected by the PC. The card operates properly again, after a power down / power up cycle of the PC.

The cards with the following version numbers may exhibit this issue: v128 (0x80), v129 (0x81), v130 (0x82), v131 (0x83), v132 (0x84), v133 (0x85), v134 (0x86), v135 (0x87), v136 (0x88), v160 (0xA0), v161 (0xA1). Cards with other version numbers do not present this issue.
