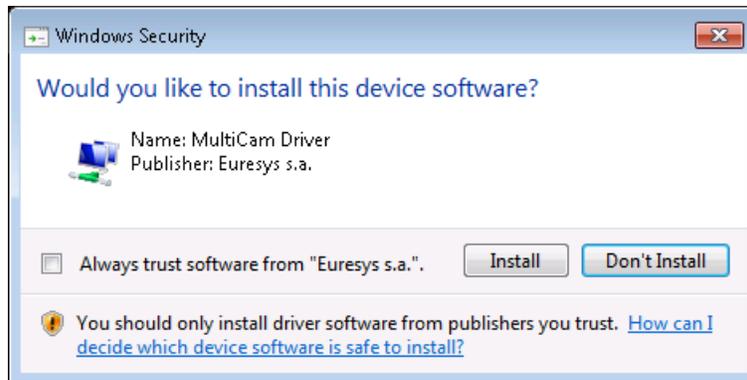
- [KB3033929](#) (provides support for SHA-256 certificates which are required by Microsoft): without this update, a "Windows cannot verify the digital signature for the drivers required for this device" (code 52) error will prevent the MultiCam drivers from loading.
- [KB2921916](#): this hotfix avoids the "Would you like to install this driver software?" dialog to pop up at each driver installation, even if the user checked the "Always trust software from "Euresys s.a." check box (see picture below) before clicking on the *Install* button. Note that the silent-mode installations will be blocked by this message until you perform this manipulation.
