MultiCam™

Release Notes for MultiCam 6.9.6

November 6, 2015

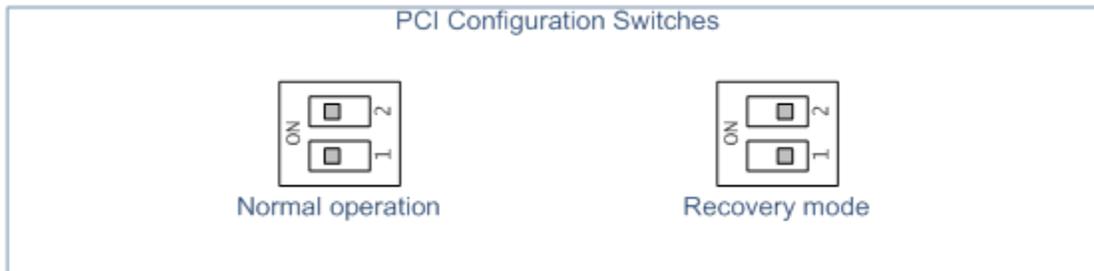
Grablink Base, DualBase, Full and Full XR feature a set of configuration switches.

For normal operation of the board, both switches must be in the ON position.

Should recovery mode be enabled by error, the Grablink board appears as "GRABLINK Base/DualBase/Full/Full XR (Recovery)" in Windows Device Manager and is not functional. To restore normal operation, power off the PC, change the switches to normal position and then reboot.

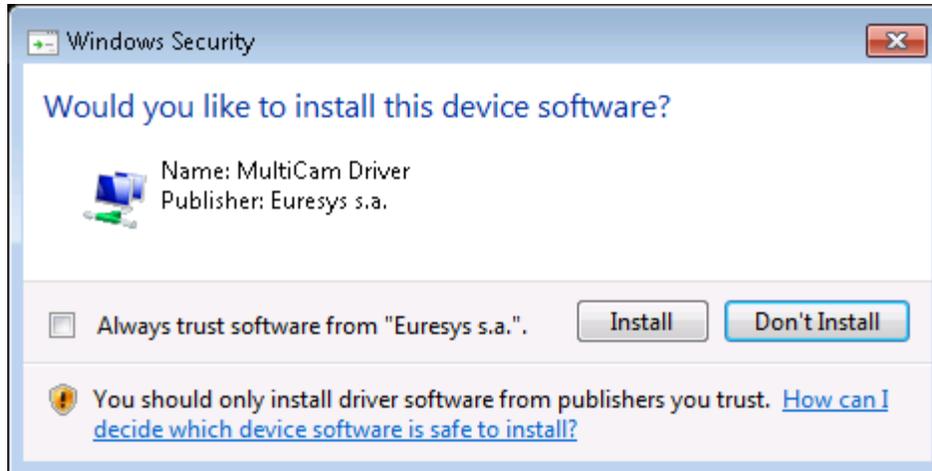
Since MultiCam 6.8.2.2066 our drivers have been signed with a new digital certificate. Consequently, in Windows Vista and later, the following message box will appear at driver installation:

All you have to do is to check the *Always trust software from "Euresys s.a."* option then click on the *Install* button. Once this has been done this message box will not appear again during subsequent installations. Note that the silent-mode installations will be blocked by this message until you perform this manipulation.

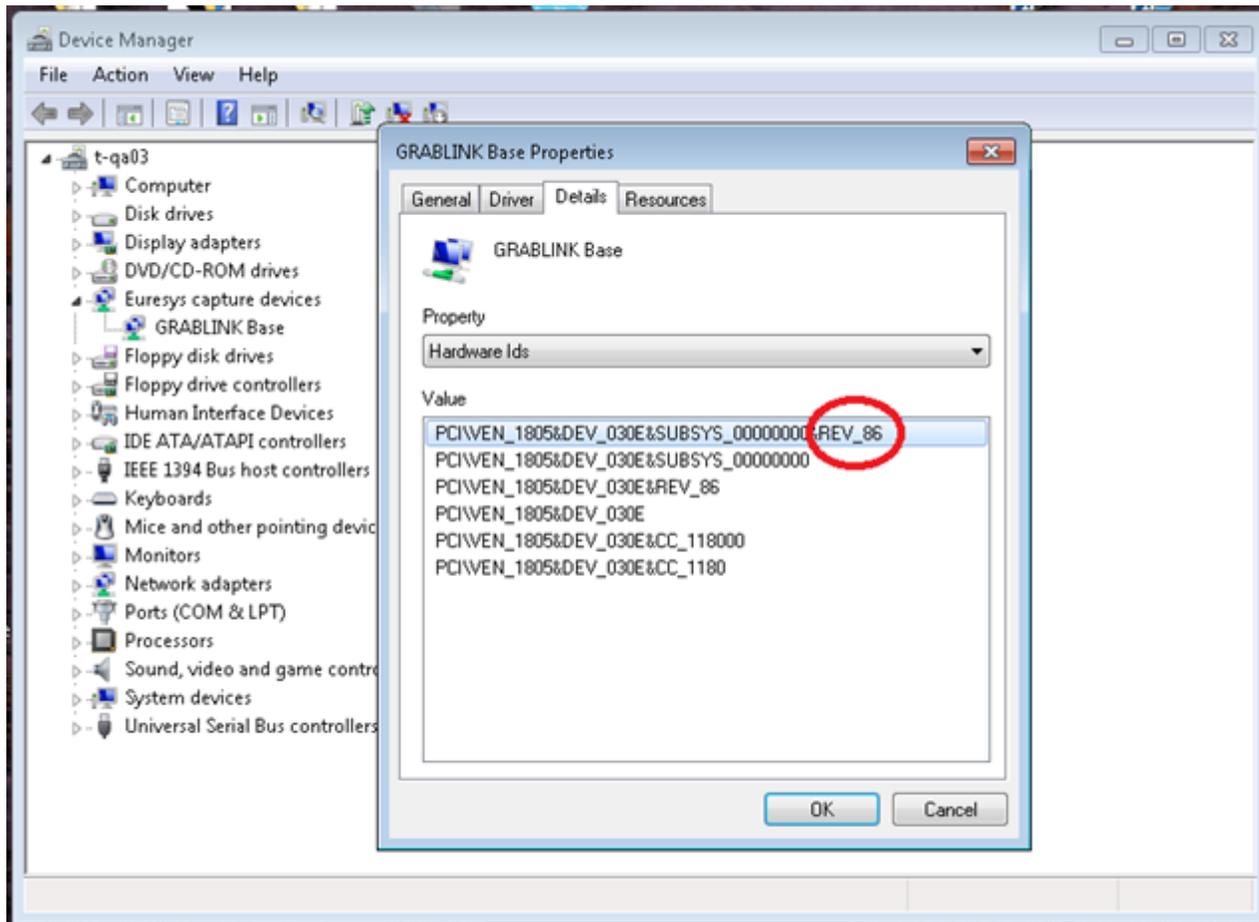
1 - Using Windows Device Manager - Properties Dialog (values are displayed in hexadecimal form)

How to read the version number

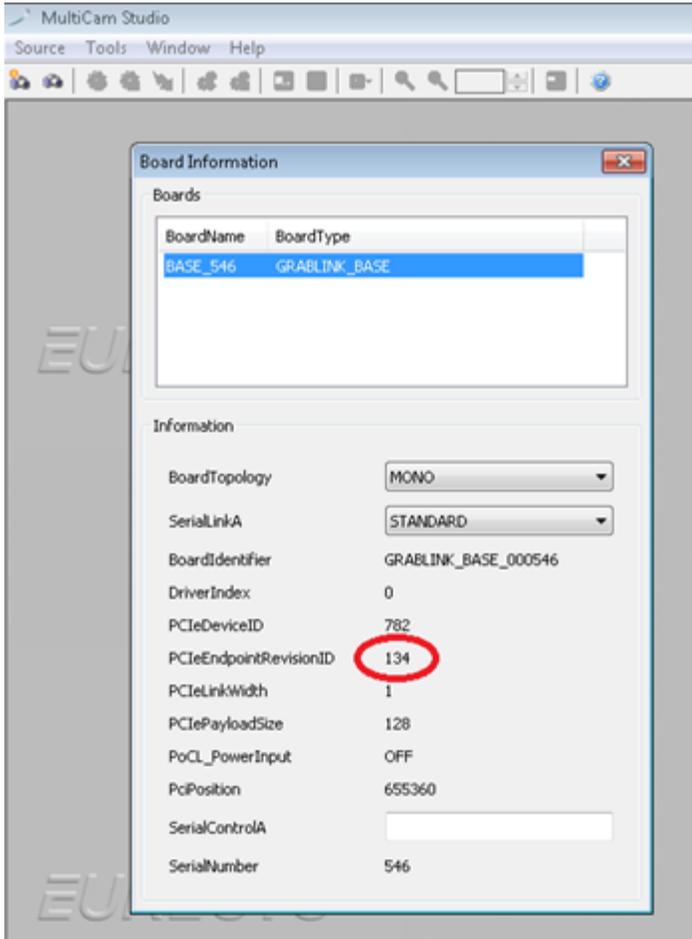
2 - Using MultiCam Studio - Board Information Dialog (values are displayed in decimal form)
